TECHNICAL MEMORANDUM
NO. ME-1-52

EVALUATION OF OXIDATION-RESISTANT COATINGS
IN A
WATER-STABILIZED ELECTRIC ARC
AT TEMPERATURES TO 2325°C (4215°F)

BY
DOMENIC J. MOLELLA

MAY 1962

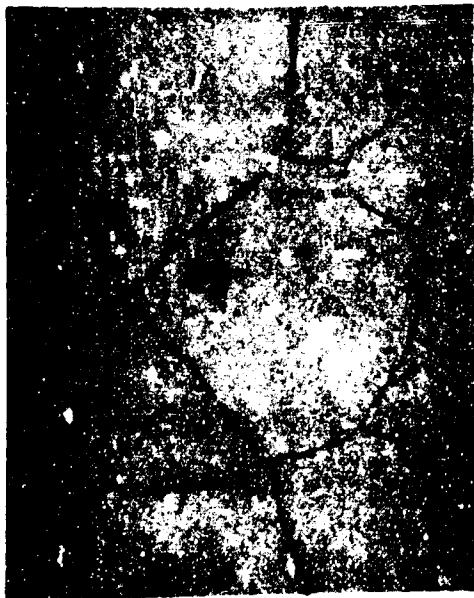
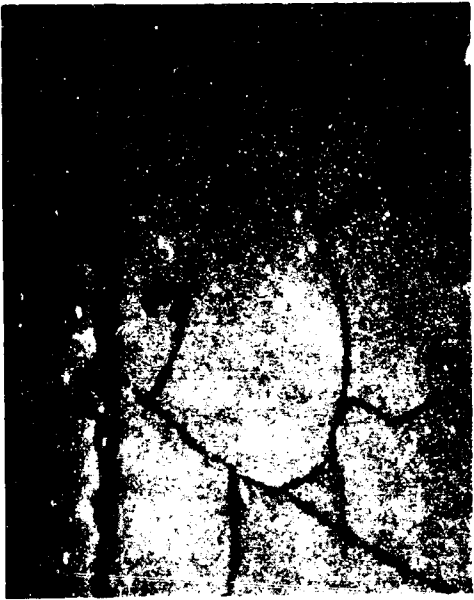
Figure 12 Microstructure of Molybdenum Disilicide coating on molybdenum +0.5% of Titanium alloy.
Etchant - NaOH + K₃Fe (CN)₆

Before Plasma-Arc Jet test. Note excellent metallurgical bond at very thin interfacial zone.

1. Coating
2. Interfacial zone
3. Base metal

After Plasma-Arc Jet test 0.50 inch from nose tip. Note growth of interfacial zone and also note that coating and base metal remained intact.

After Plasma-Arc Jet test at nose tip. Note uniform oxidation of base metal and slight amount of floating of base metal to the surface.

1. Oxidation
2. Floated base metal
3. Base metal
